Kalamazoo River Superfund Site

Allied Paper, Inc. Operable Unit and Plainwell Removal Action

USEPA, MDEQ, and KRSG Meeting and Site Tour
October 7 & 8, 2008

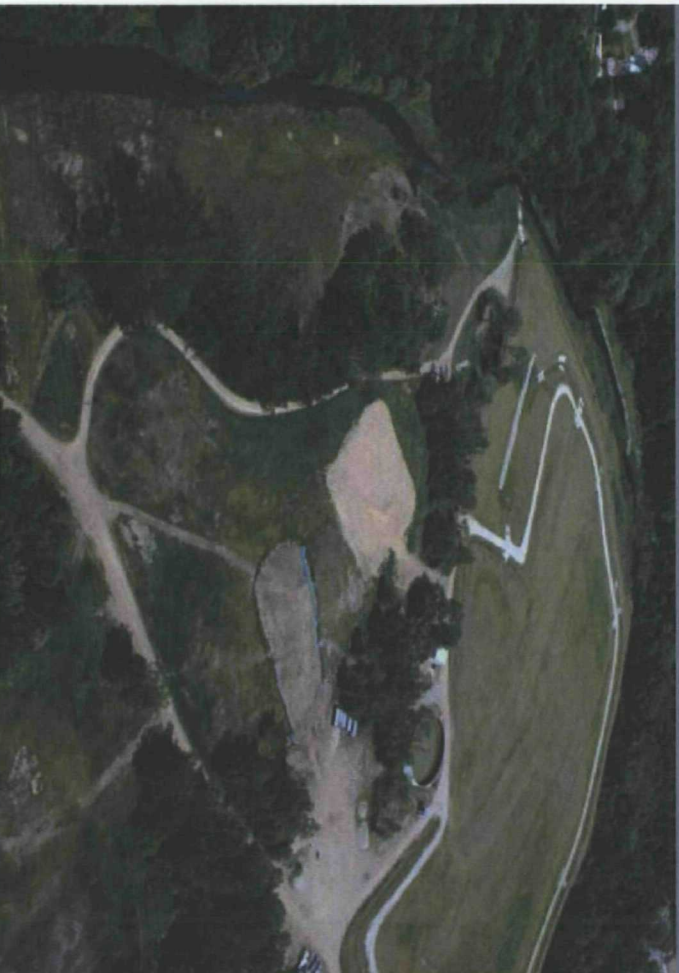
Allied Paper, Inc. Operable Unit: Current Situation

- USEPA/MDEQ published the Remedial Investigation Report in March 2008
- MHLIC will prepare the Feasibility Study Report and submit to USEPA in 2009
- Options for addressing remaining areas at the OU will be evaluated in the Feasibility Study
- To date, **no detections of PCBs** above established criteria in the groundwater-surface water interface zone or in the influent or effluent of the groundwater treatment system

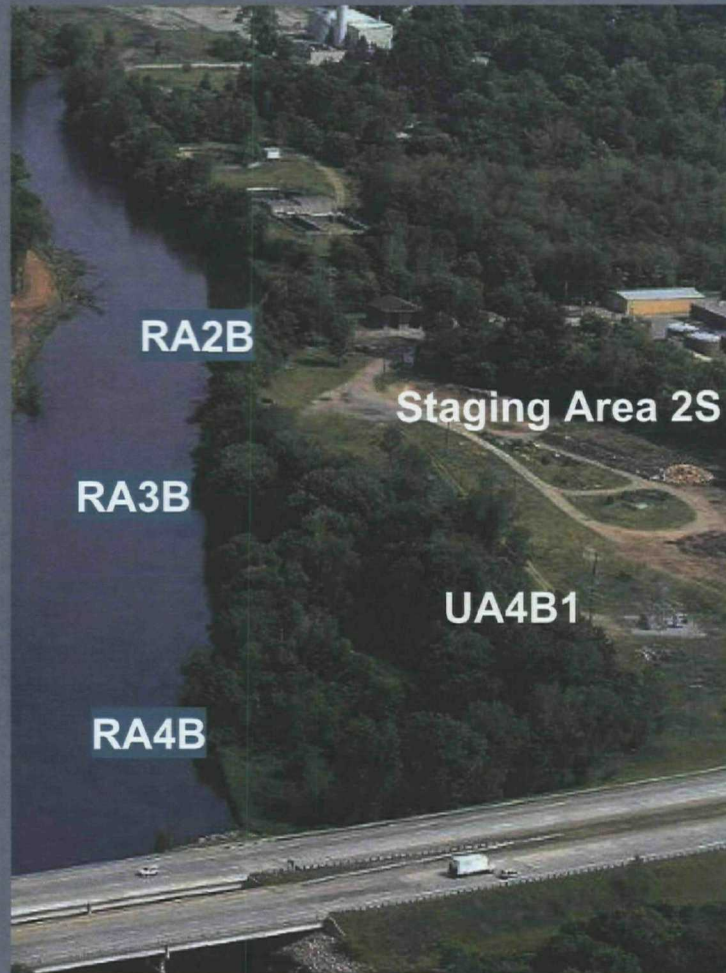
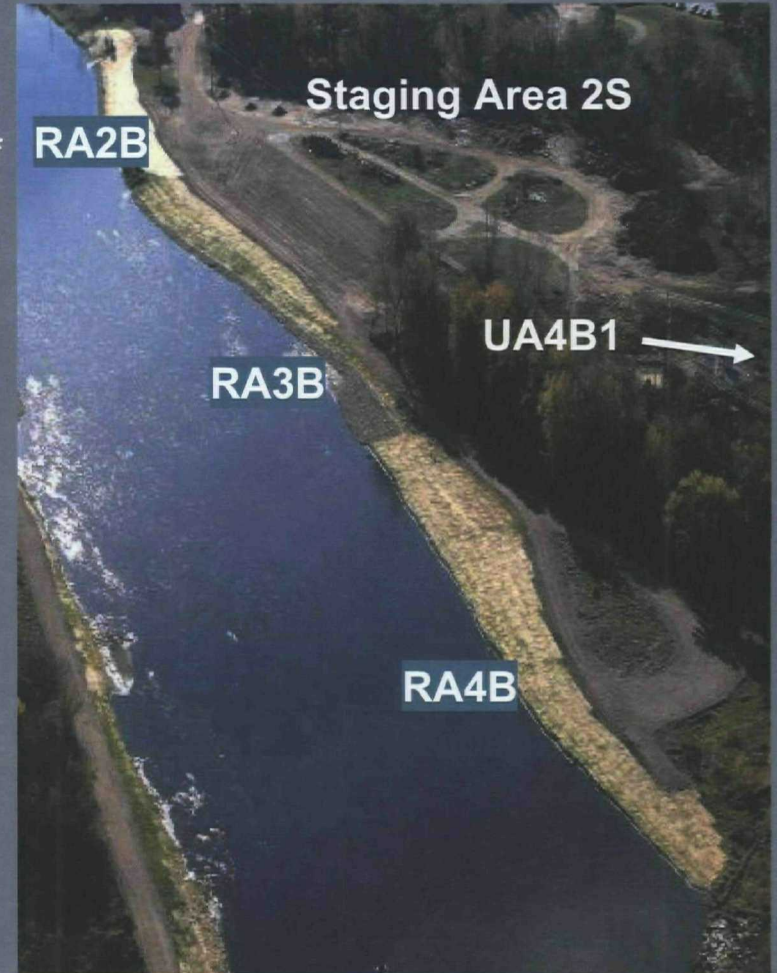
Removal Areas 2B, 3B, and 4B Upland Area 4B1

Before (at left) and after (at right) views of the upstream removal areas on the southern bank of the river.

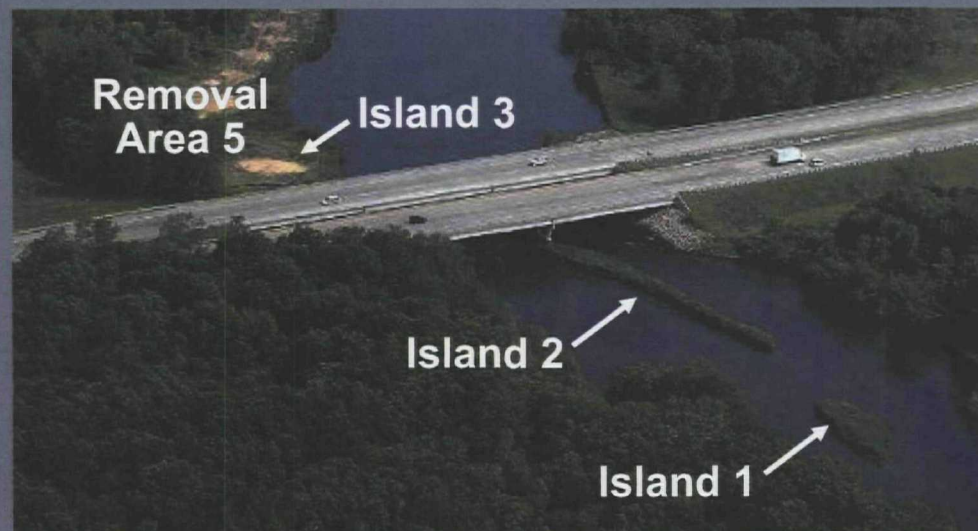
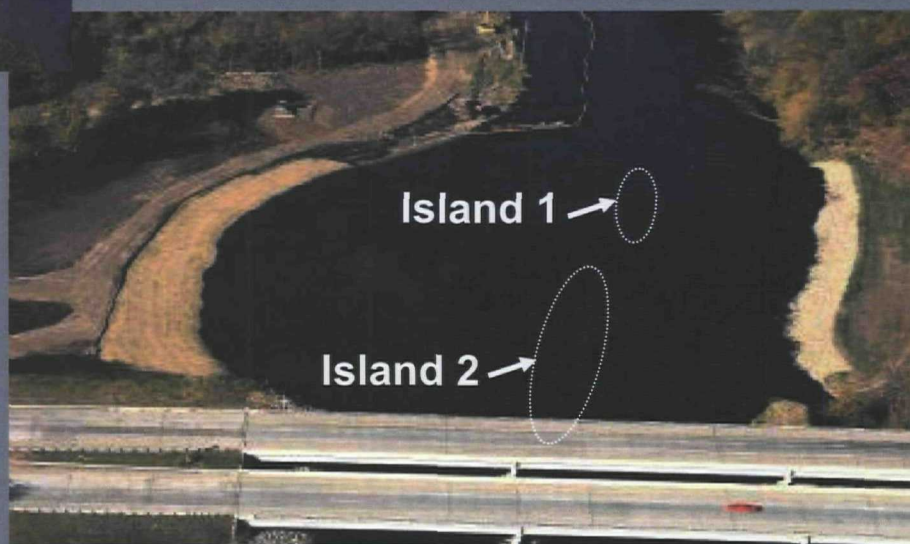
Islands 1, 2, and 3 Removal Area 5

In July and August field crews were at work in Removal Area 5 and on Island 3, and by September were removing the two islands just downstream of the US-131 Bridge. Before (left) and after (below) photographs show the complete removal of Islands 1 and 2.

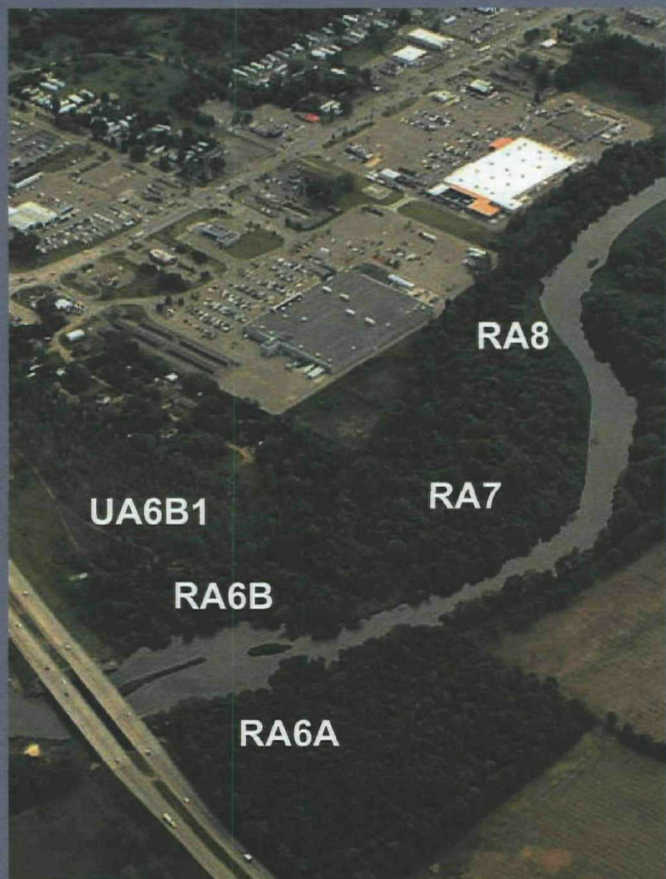
Downstream of the US-131 Bridge
in May 2007

Initial plans called for excavation efforts in the 2007 season to end with Removal Areas 6A and 6B, but the project team was able to work up through Removal Areas 7 and 8, getting a jump start on the 2008 season.

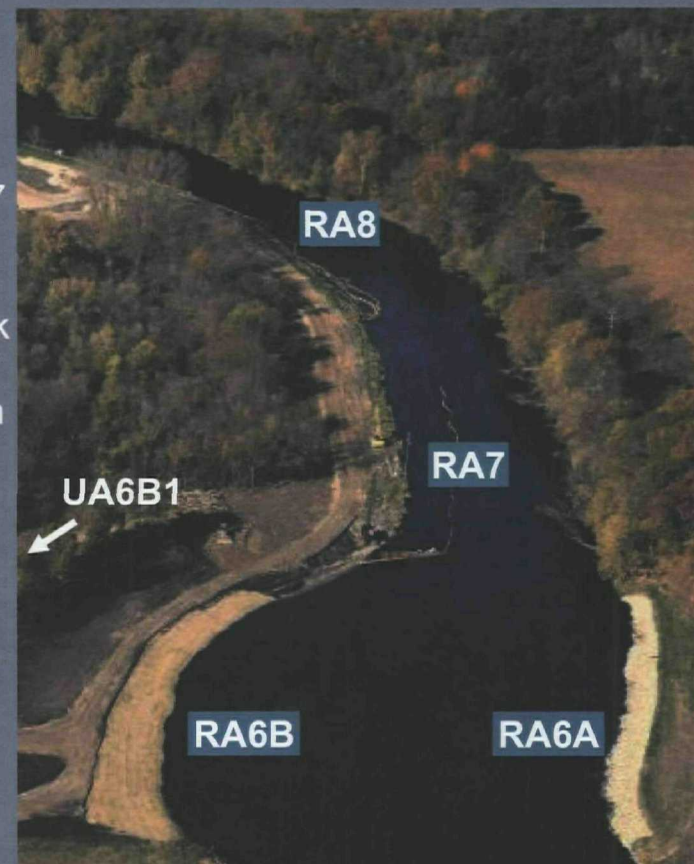
Downstream of the US-131 Bridge
in October 2007

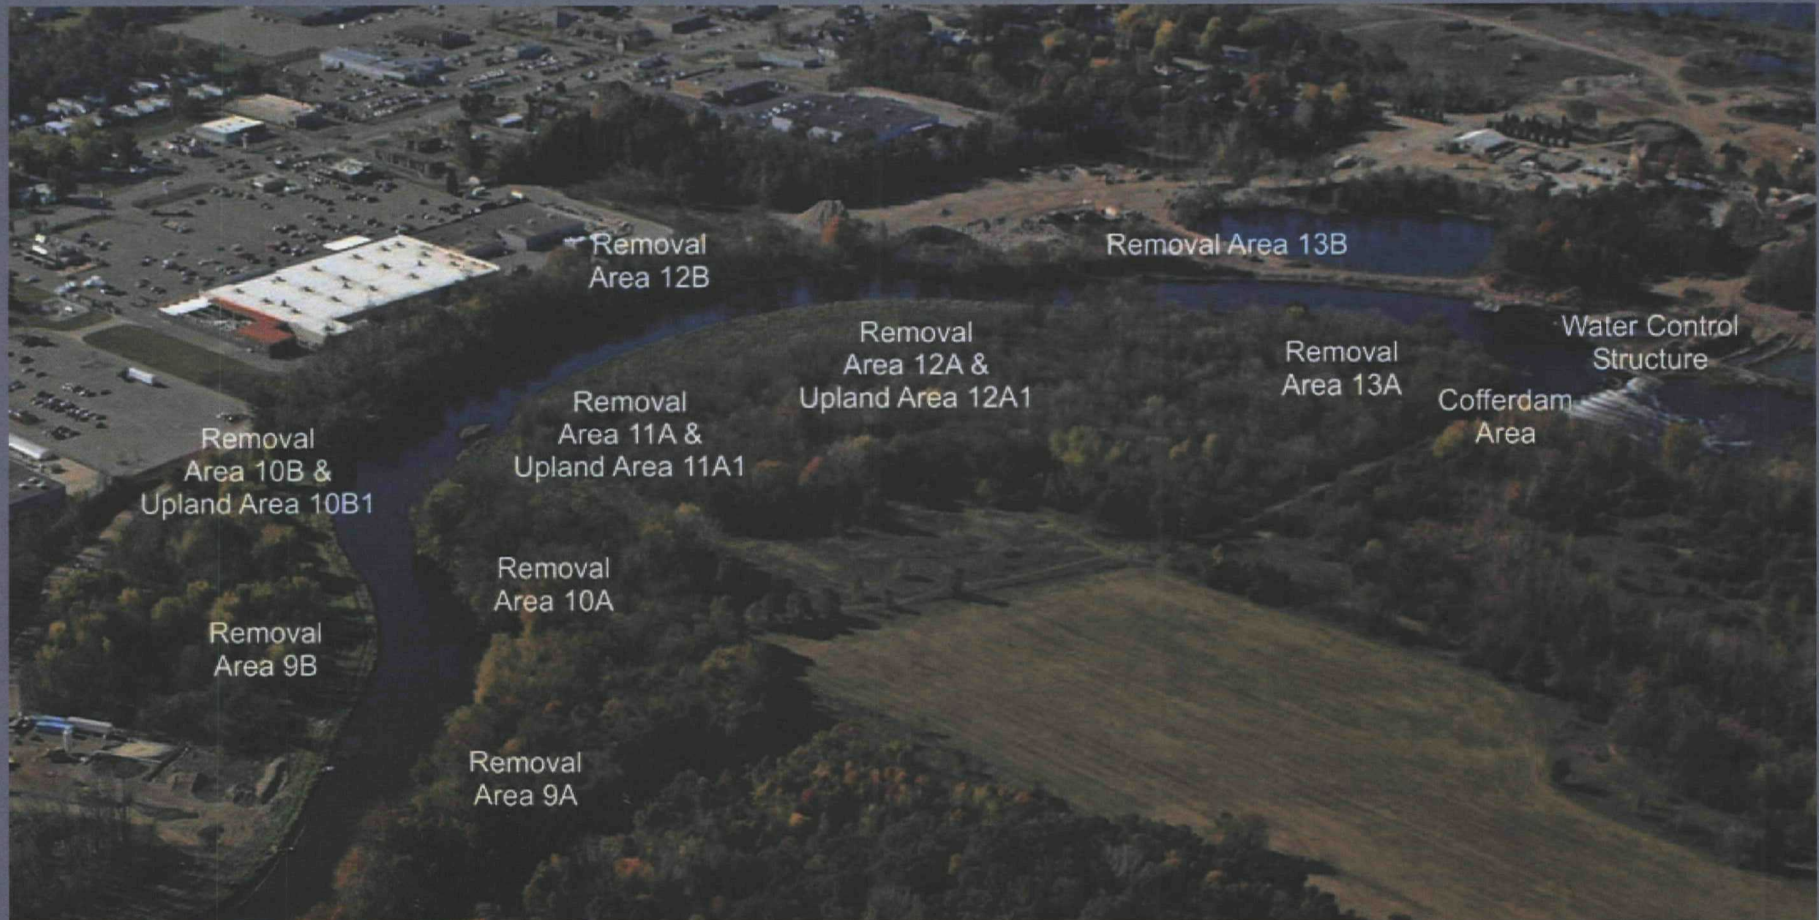
2008 Season: Overview

- Construction Season: March through December
- 83,000 cy of material to be removed over 17.5 acres
- Cofferdam and Water Control Structure installation, operation, and removal

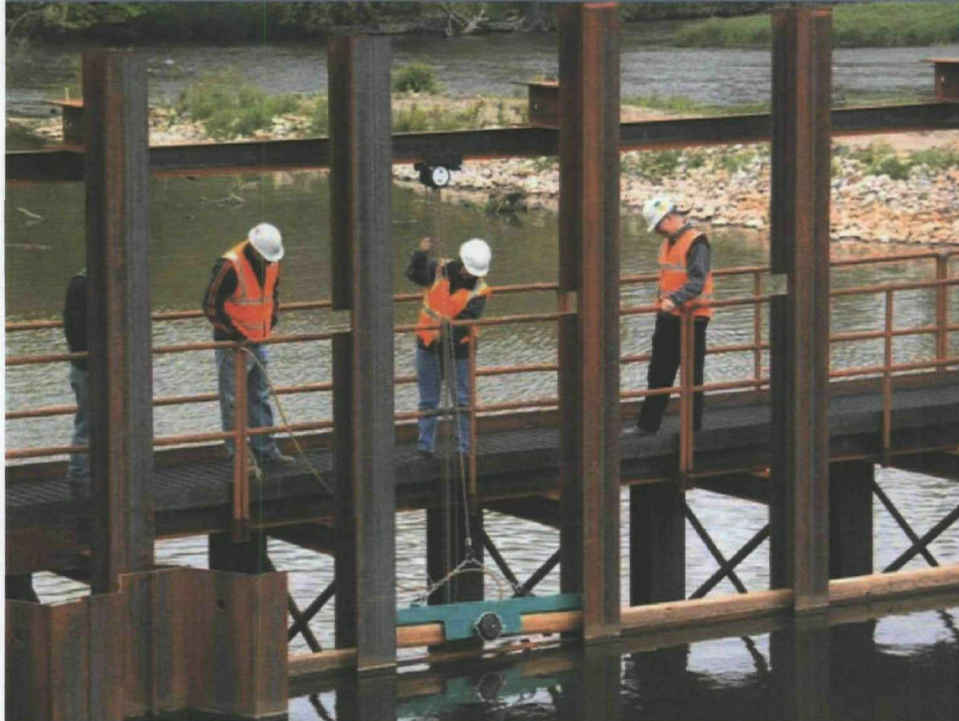
Sharon Hanshue of the Michigan Department of Natural Resources pulling out the first stop log in the structure (May 2008)

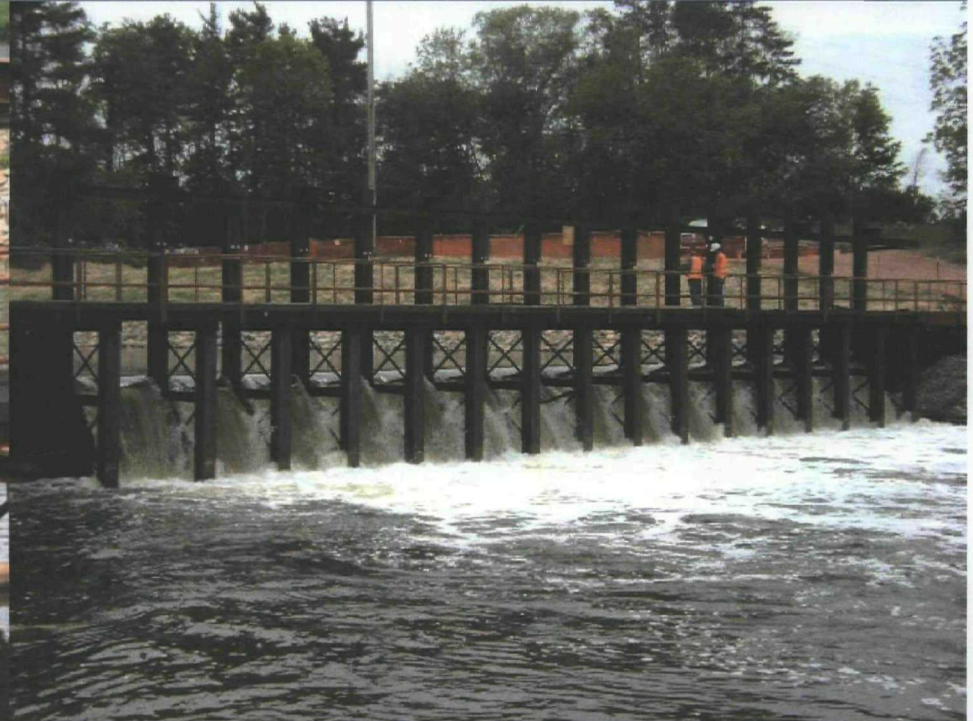
View of the structure approximately two weeks after pulling the first stop log (May 2008)

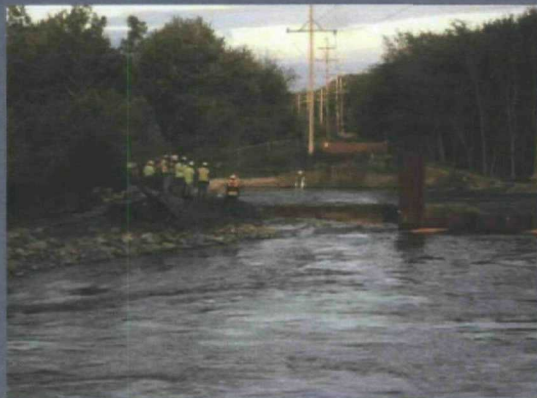
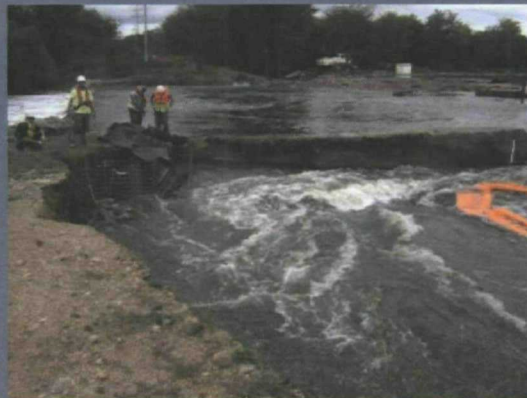
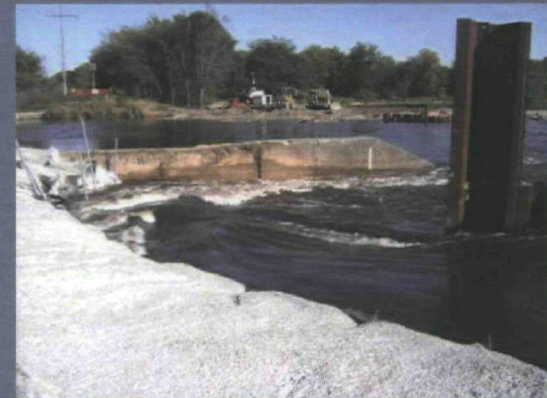
- Activated Plainwell Dam No. 1 Emergency Action Plan
 - City of Otsego closes two bridges downstream
- Cleared debris forest from WCS
- Cut stop logs to increase relief discharge
- Cut cofferdam wall to increase relief spillway dimensions and discharge
- Installed makeshift gabion structure at erosion hole
- Patched slope downstream of WCS

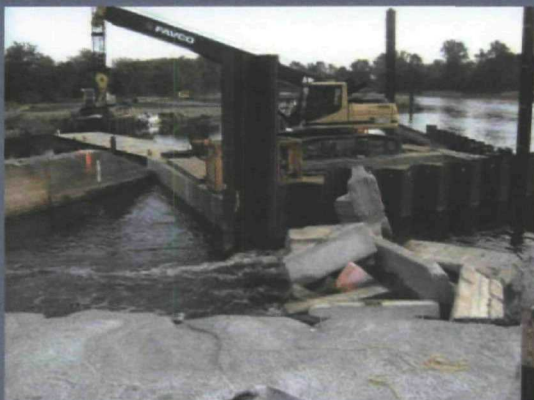
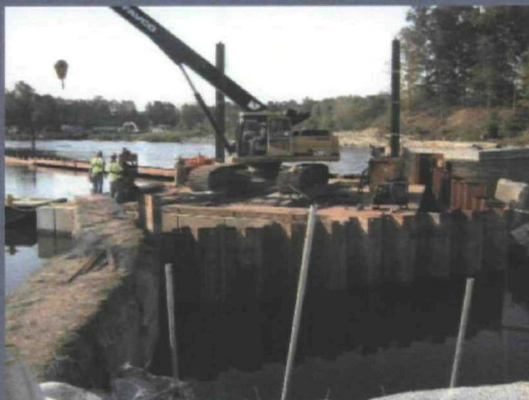
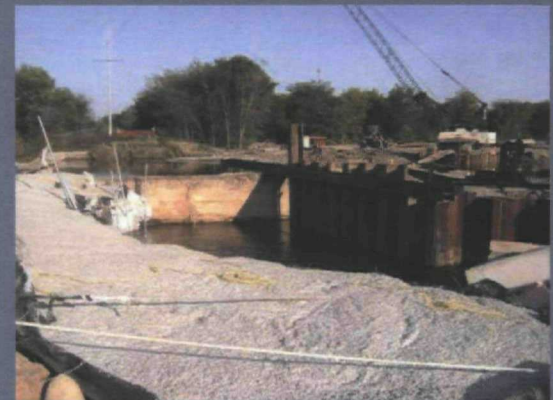
- Mobilized sectional barge to interior of cofferdam area
- Closed gap in cofferdam with concrete block berm
- Drove sheet pile to restore hydraulic control of cofferdam area
- Observed restored banks and remaining removal areas as water receded
- Resumed excavation activities week of September 22

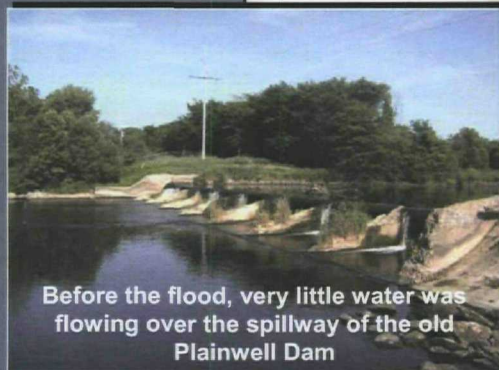
- At the end of the 2008 season, the project team will remove the water control structure, restoring the flow of the river through the historical Western Channel

Before the flood, very little water was flowing over the spillway of the old Plainwell Dam
